Manhole Inspection Summary

Manhole # S11YY1001MH

Insp Date: **10/18/06 2:16 PM**

Location Address: **5600 PIMILICO RD**

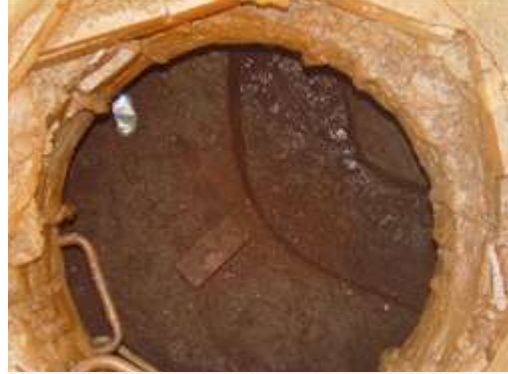
Top View

Evidence of surcharge - Bench debris. Channel debris. Corroded steps.

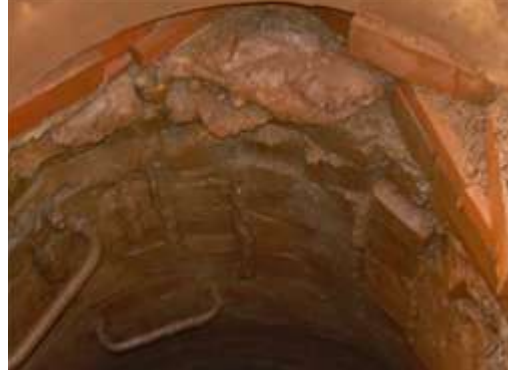
Defect

Frame leaks. Adjustment and Corbel deterioration, loose brick and infiltration. Barrel infiltration.

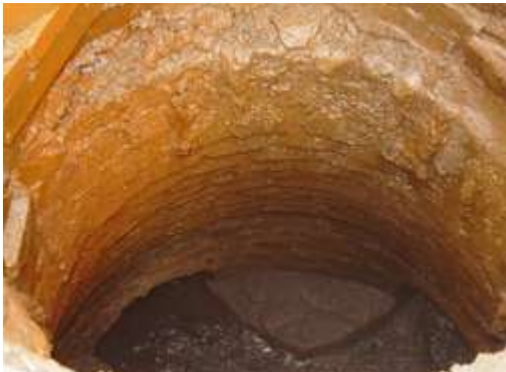
Defect

Adjustment deterioration and infiltration. Corbel and Barrel infiltration.

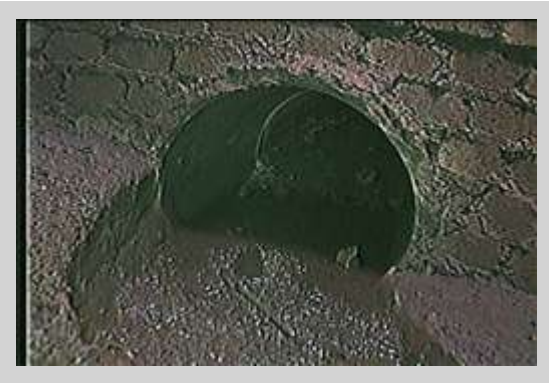
15 in. Circular Gravity Sewer Pipe Out @ 12 O'Clock

Barrel deterioration and infiltration.

Deposits: ☐ None ☒ **Mud** ☐ Sludge ☒ **Debris** ☐ Grease

Silt Depth: **4** (in.) Deposits Extent: **Medium**

Infiltration: **Evidence** Pipe Seal Cond: **Unknown**

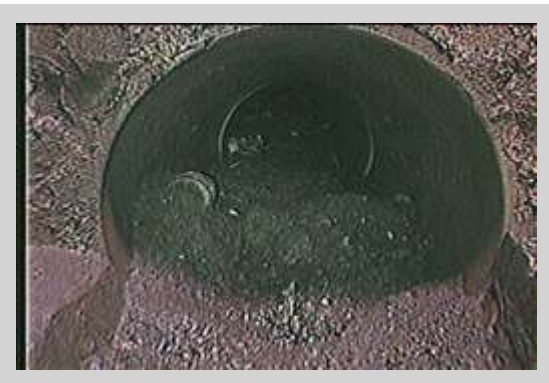
15 in. Circular Gravity Sewer Pipe In @ 3 O'Clock

Deposits: ☐ None ☒ **Mud** ☐ Sludge ☐ Debris ☐ Grease

Silt Depth: **4** (in.) Deposits Extent: **Medium**

Infiltration: **Evidence** Pipe Seal Cond: **Unknown**
